UNITED STATES ENVIRONMENTAL PROTECTION AGENCY

Re: Notice of Violation
Compliance Evaluation Inspection
EPA I.D. No.: IND044210896

COMPLIANCE EVALUATION INSPECTION REPORT

INSTALLATION NAME: Dexter Axle Company

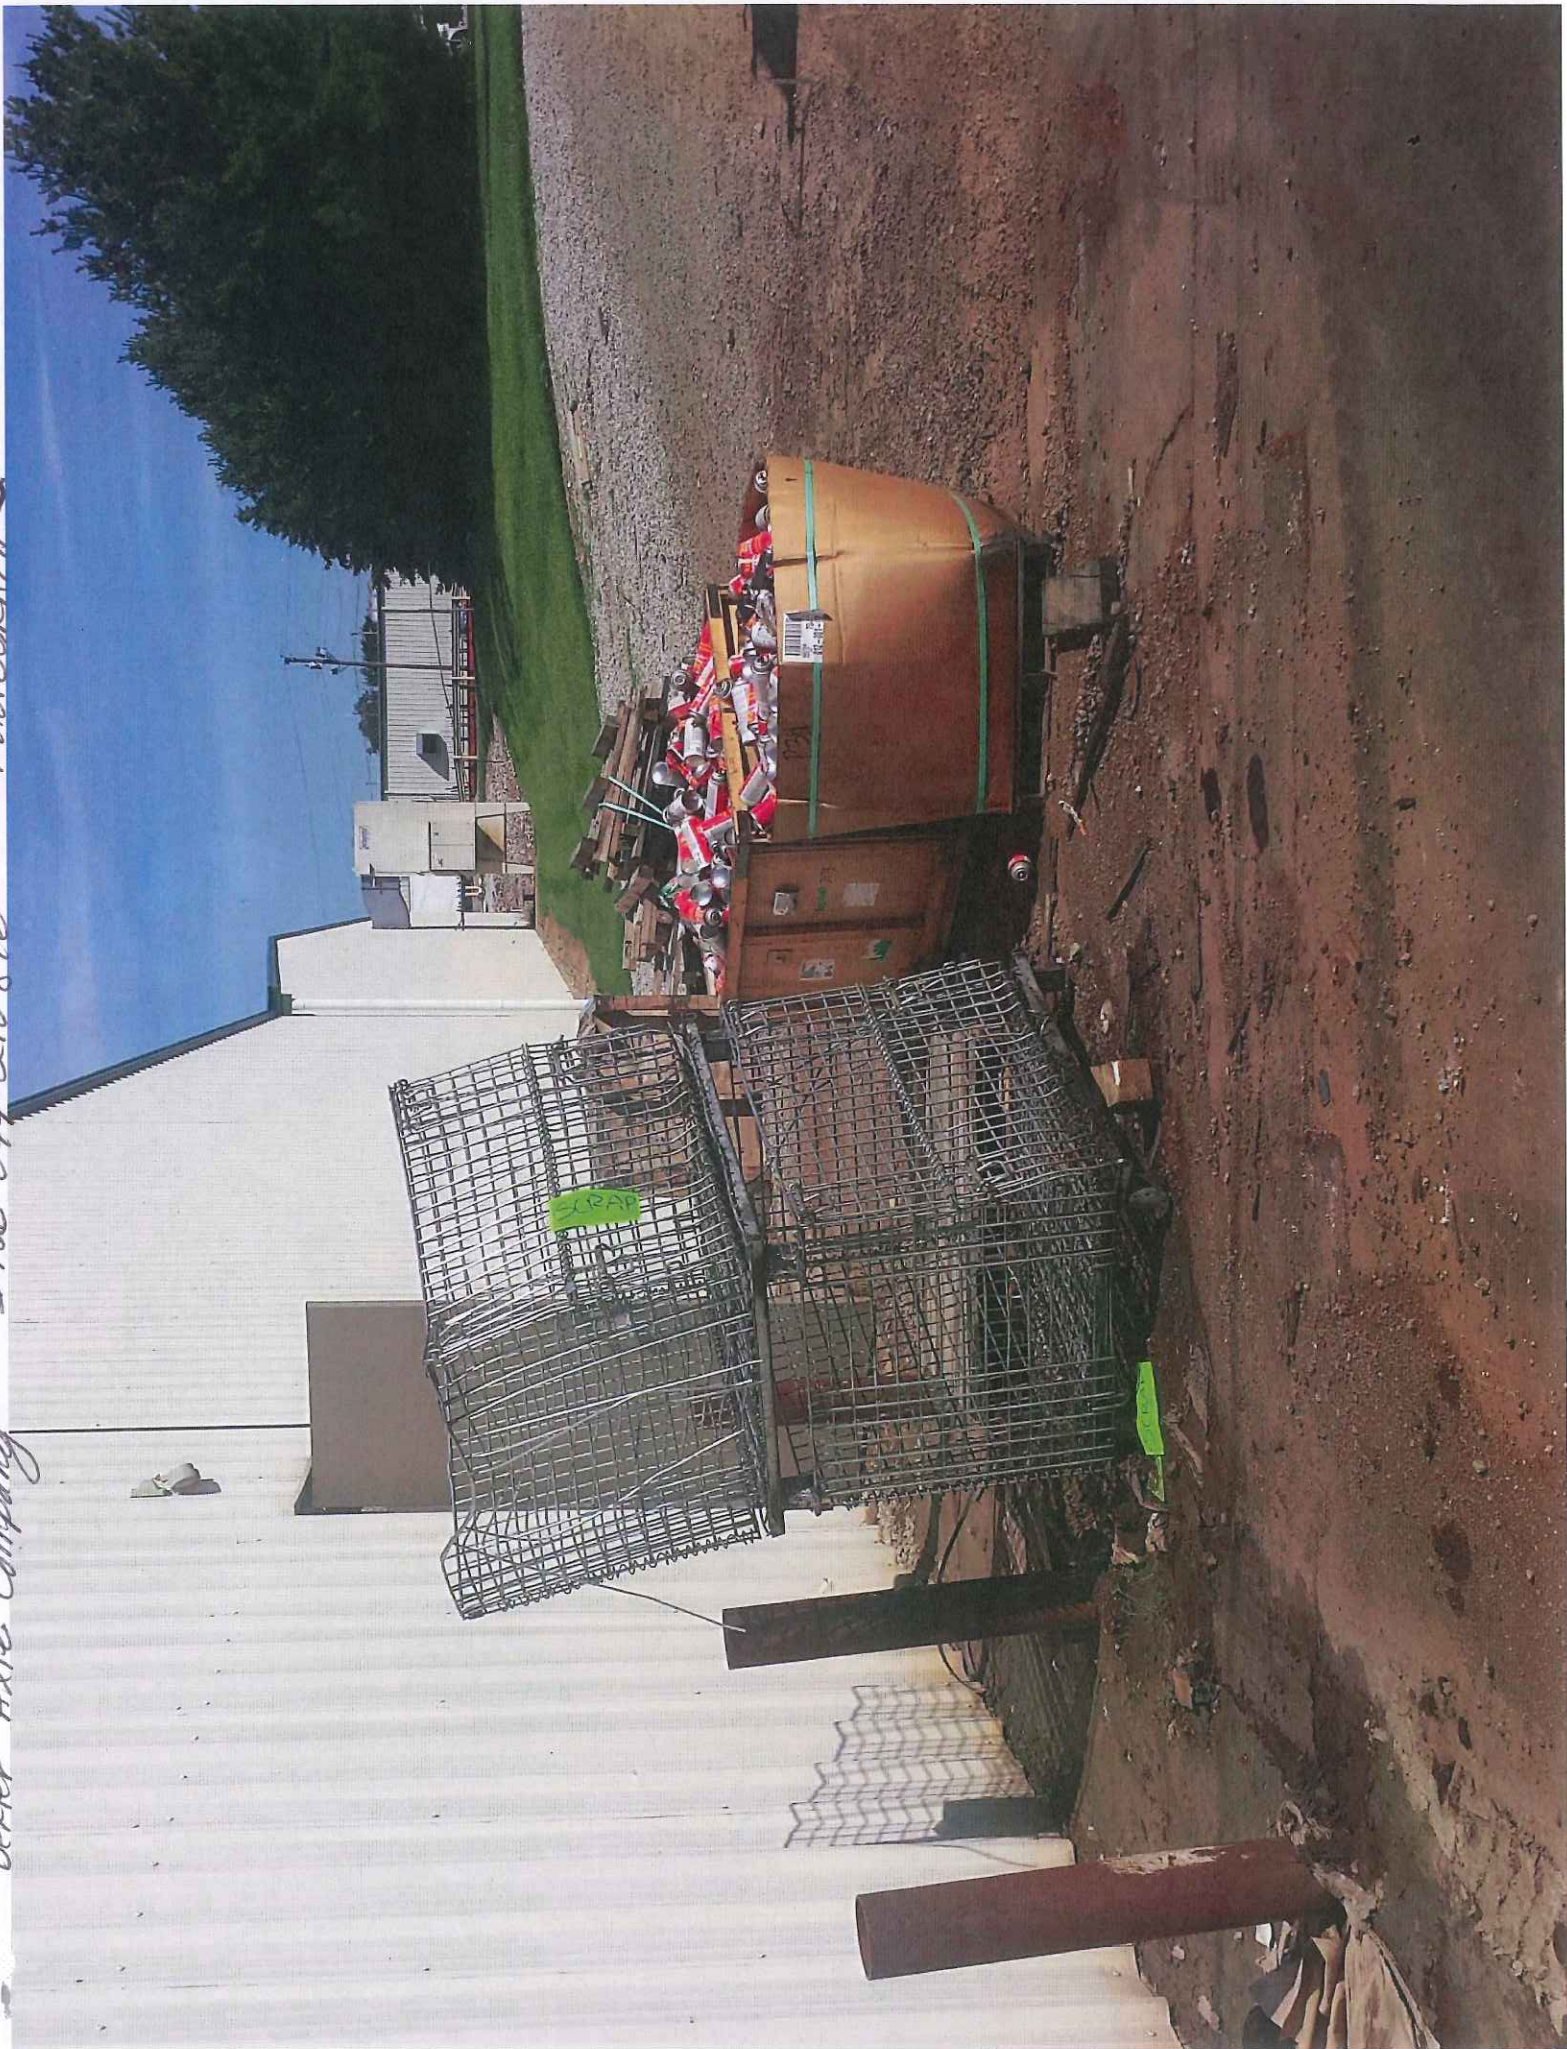
Dexter Axle Company INW 044 210 896 PHOTOGRAPH 5

1. There was no posting of emergency contacts;
2. The aisle space in the building was non-existent as the building is used for both material and waste storage and I could not get inspect or examine containers closely because my access was obstructed;
3. There appeared to be only one 55-gallon container of hazardous waste in storage (see Photograph1);
4. There were numerous boxes with aerosol paint cans and bags of aerosol paint cans (see Photographs 2);
5. There was aerosol can puncturing unit located in the northeast corner that was not labeled (see Photograph 3);
6. There were boxes of universal waste amps that were not labeled or closed as well as loose lamps that were not contained (see Photographs 3 and 4); and
7. There were several boxes of aerosol spray cans located outside between Building 1 and the Hazardous Material Management Building (see Photograph 5).
